Las Vegas Wash Vegetation Monitoring Report, 2022

April 2024

SOUTHERN NEVADA
WATER AUTHORITY®

Las Vegas Wash
Coordination
Committee

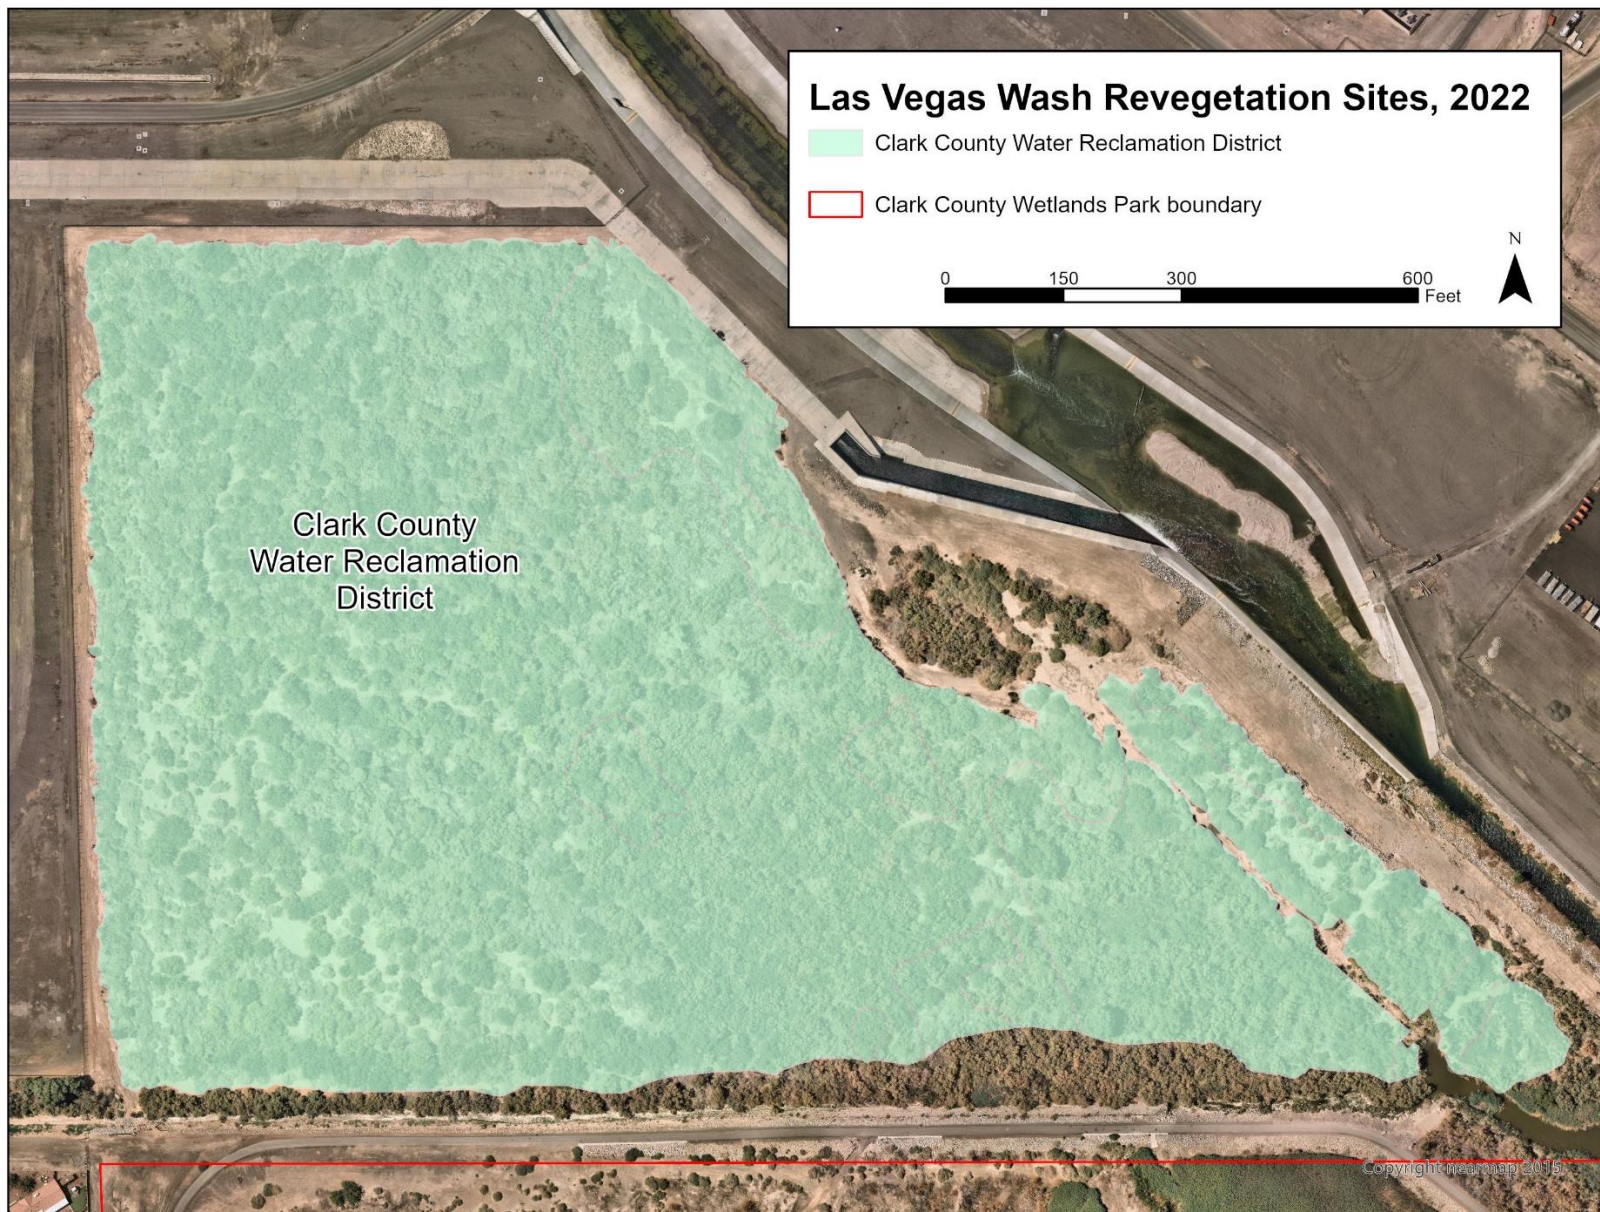
Figure 6. Aerial photograph of the 2022 delineated CCWRD revegetation site.

The CCWRD revegetation site (Table 6, Figure 6) was monitored with ArcGIS in 2022 for the fourth year in a row and will likely continue to be monitored this way moving forward. In 2020, it was determined that access was difficult to any interior area of the site. Although vegetation is visible along the perimeter, that vegetation would not be an accurate representation of the entire site.

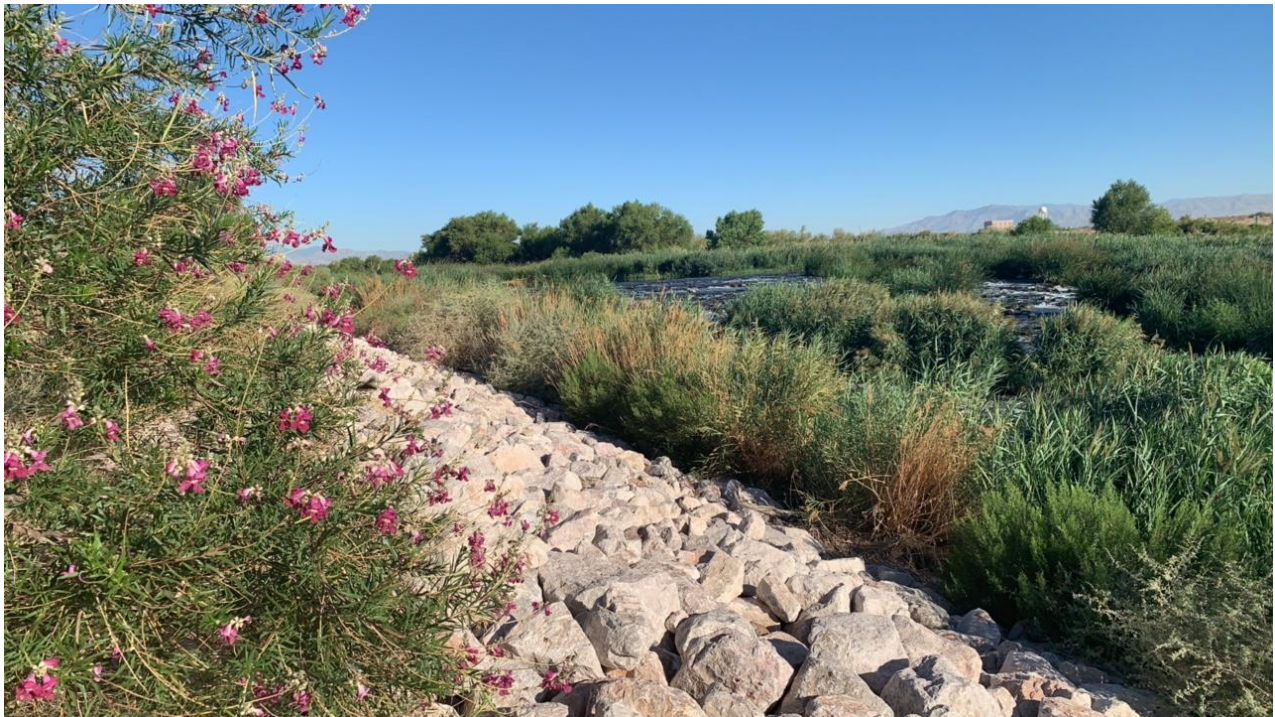
All sites at the DU Wetlands No. 1 Weir were monitored using ArcGIS in 2022 (Table 10, Figures 10 and 11). Of the two planted sites, DU Wetlands No. 1 South (DU1S) decreased in cover from the previous year, while DU Wetlands No. 1 Emergent (DU1E) increased. Total cover for both sites was the same as recorded in the previous year using ArcGIS. Therefore, this may indicate that using ArcGIS can cause errors in both over and underestimating total cover.

Figure 10. Photo overlooking site DU Wetlands No. 1 Emergent South.

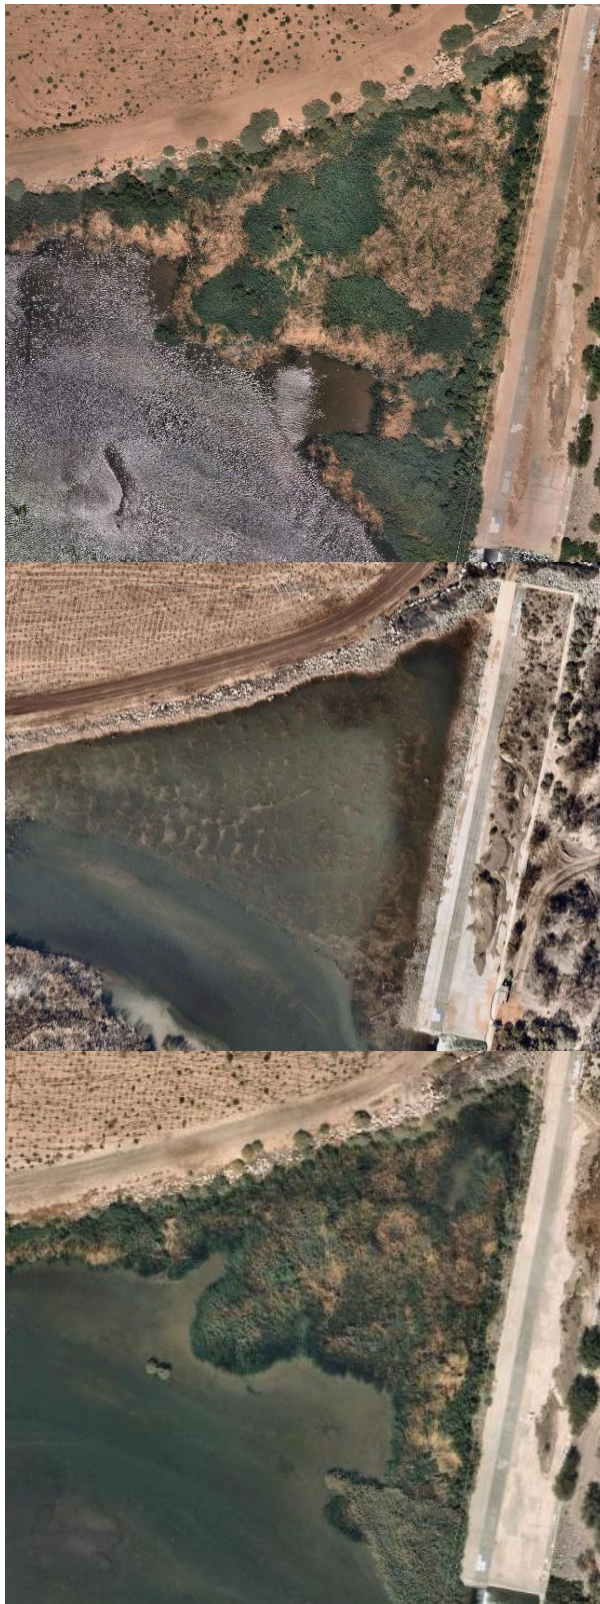
Figure 18. Upstream Pabco North’s transformation from February 2020 (top), October 2021 (middle) to October 2022 (bottom).

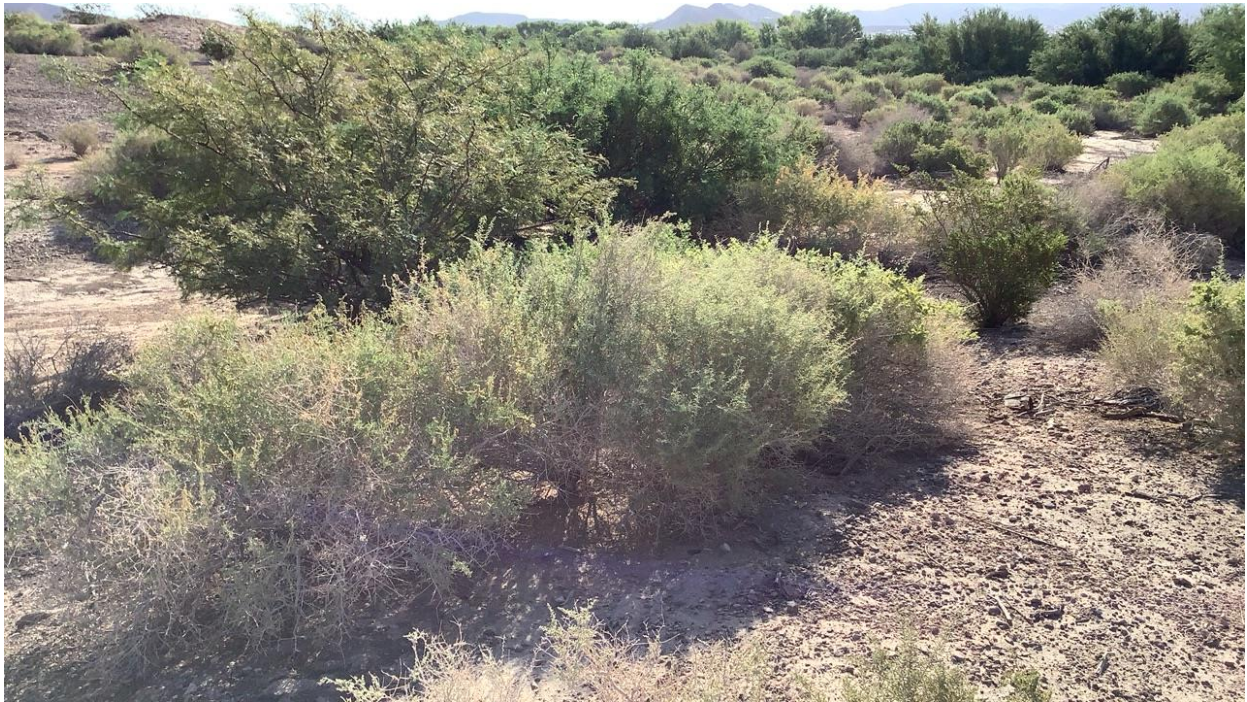
Site 111 was planted as a single site but due to being one of the larger revegetation sites along the Wash, it is broken up into 26 monitoring areas (Table 20, Figures 22 and 23). All areas were monitored in the field in 2022. However, sites S111-3, S111-4, and S111-29 were inaccessible, so they only contributed to acreage in the table below. This site is in its 15th growing season so there is not much change that occurs year to year. Total cover for this site went from 81.4% measured using ArcGIS in 2021 to 67.9% measured in the field in 2022. This decrease in total cover may be partly due to misidentifying plants while obtaining total cover in ArcGIS. Although ArcGIS is not the most accurate way to determine total cover, it allows us to get an estimated cover even when access is limited.

Figure 22. Photo of monitoring area S111-14 which is a monitoring area within Site 111.

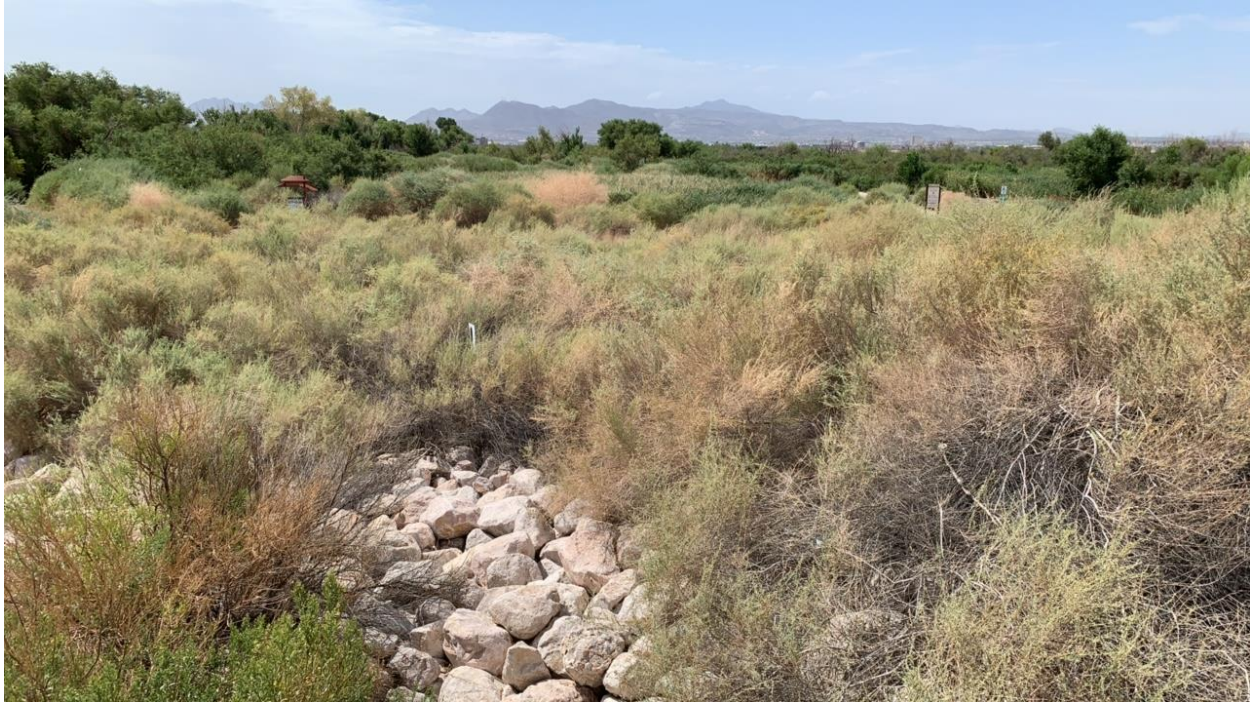
Figure 28. Photo of Upper Diversion Island, mostly dominated by four-wing saltbush (*Atriplex canescens*).

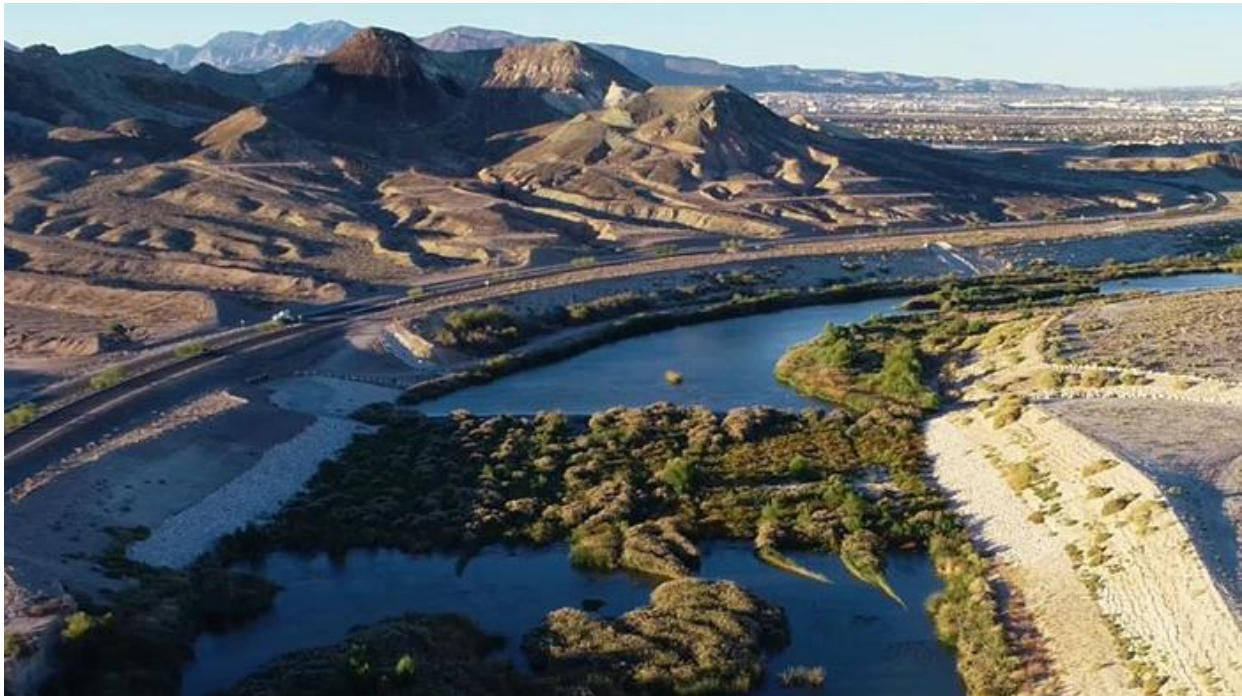
Figure 29. Aerial image of Three Kids Weir which was constructed in 2015. This weir site is the largest at 4.74 acres. Photo taken in 2020.
