Las Vegas Wash Vegetation Monitoring Report, 2023

November 2024

**Las Vegas Wash
Vegetation Monitoring Report, 2023**

**SOUTHERN NEVADA WATER AUTHORITY
Las Vegas Wash Project Coordination Team**

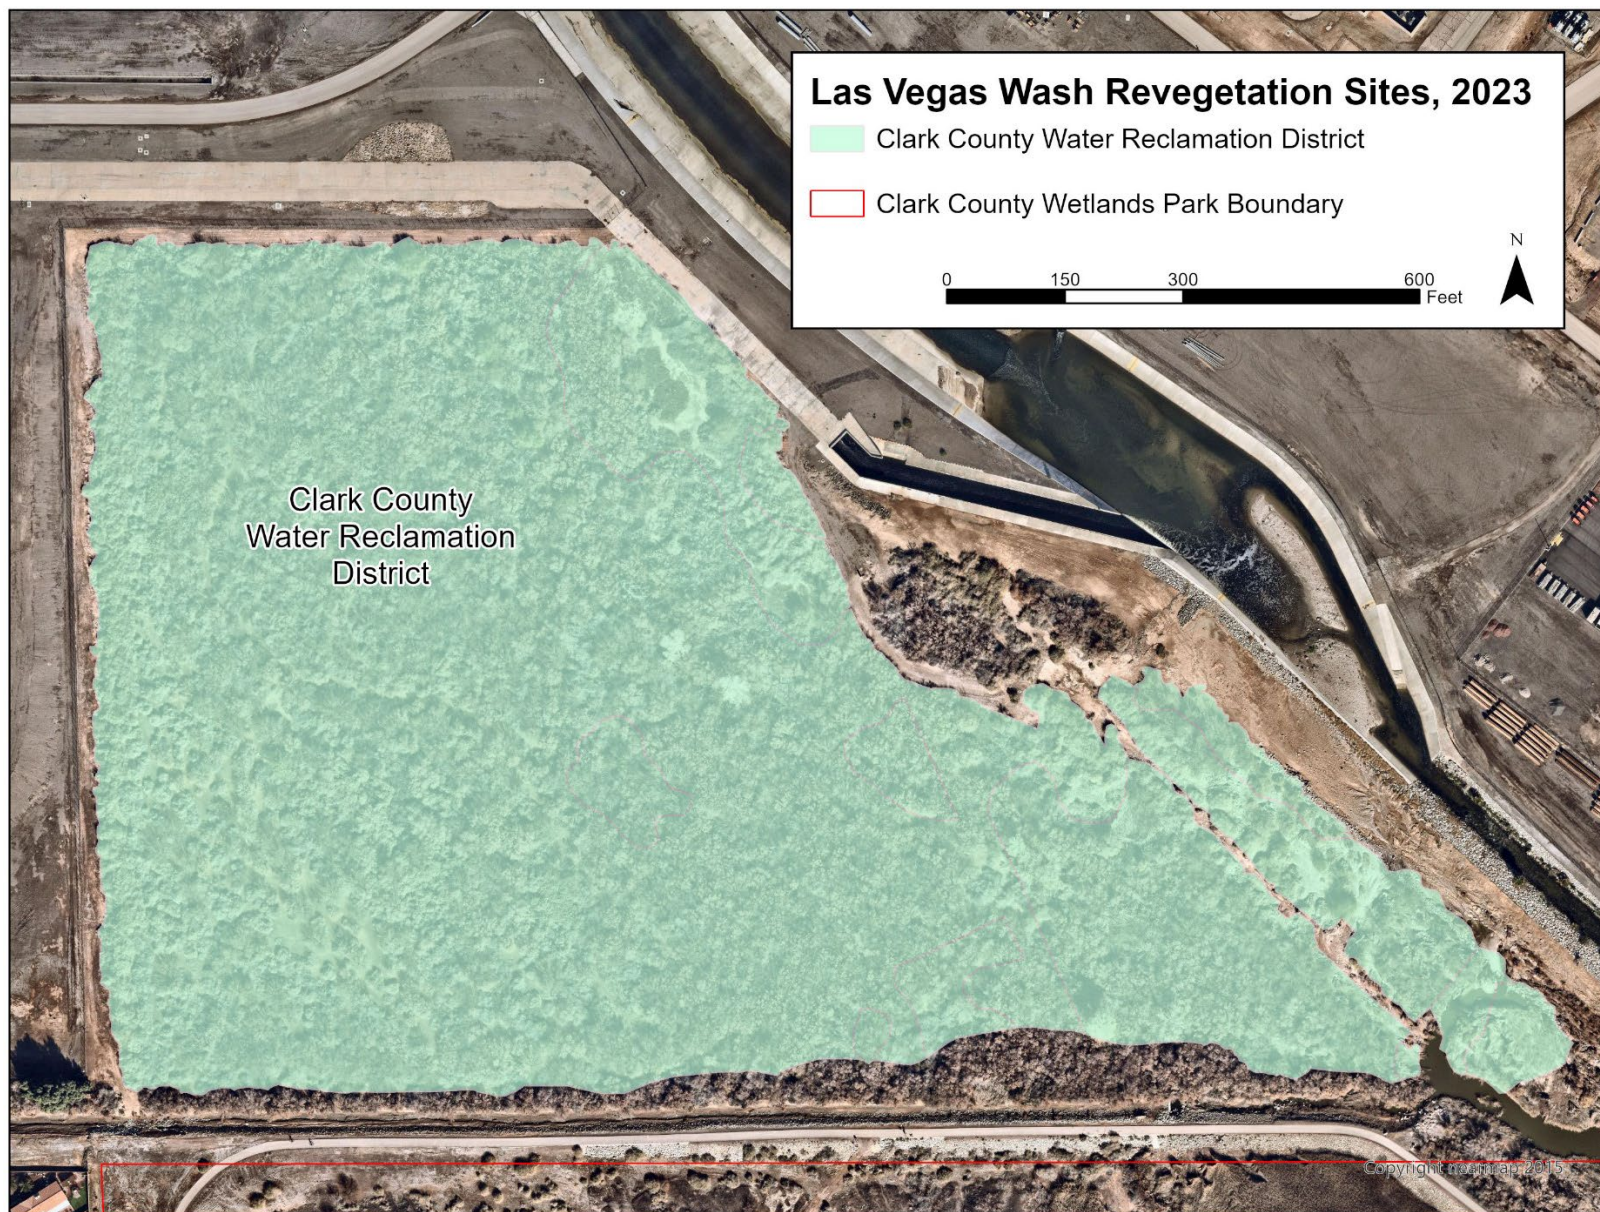
Figure 6. Aerial photograph of 2023 delineated Clark County Water Reclamation District revegetation site.

The CCWRD revegetation site (Table 6, Figure 6) was monitored with ArcGIS in 2023 for the fifth year in a row and will likely continue to be monitored this way. In 2020, it was determined that access was difficult to any interior area of the site. Although vegetation is visible along the perimeter, that vegetation would not be an accurate representation of the entire site.

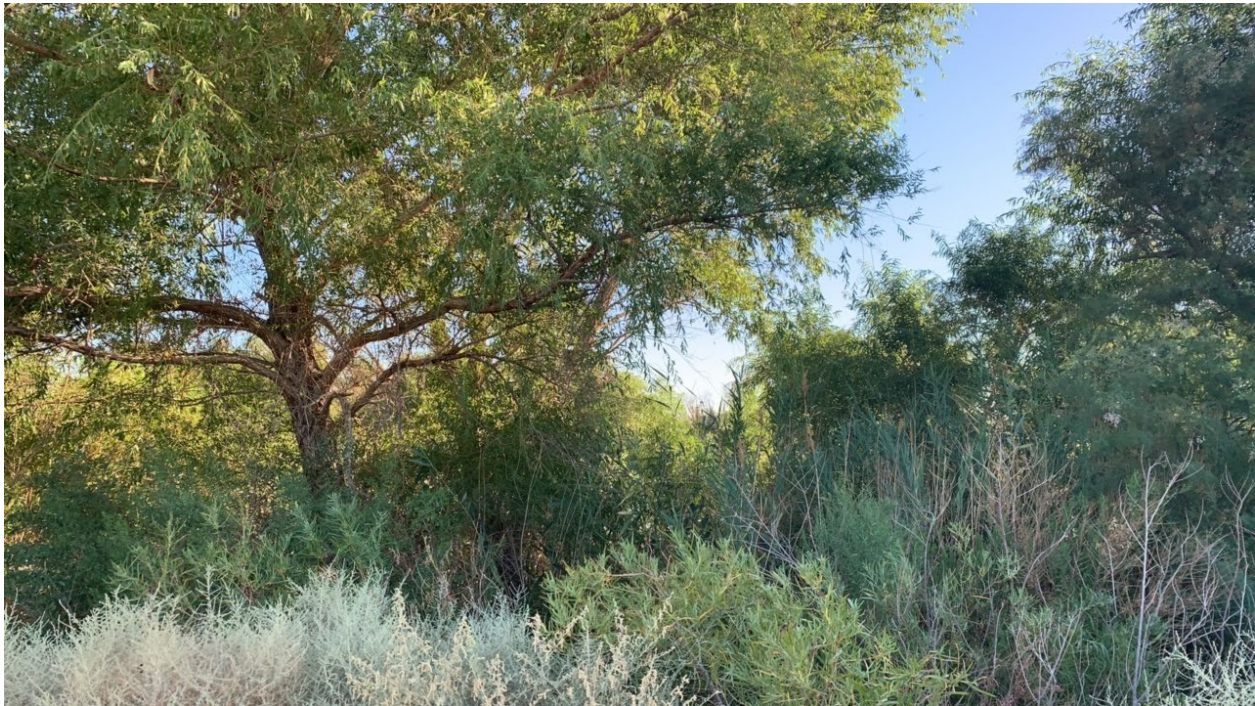
Figure 10. Vegetation at DU Wetlands No. 1 Weir Emergent.

All sites except DU Wetlands No. 1 Weir (DU1W) were monitored in the field in 2023 (Table 10, Figures 10 and 11). Total cover for sites remained the same except for DU Wetlands No. 1 South (DU1S) which increased from 50–75% recorded using ArcGIS in 2022 to 75–100% recorded in the field in 2023. Total cover recorded in the field in 2021 was the same as 2023. This is likely another example of ArcGIS being unable to accurately identify total cover of a site.

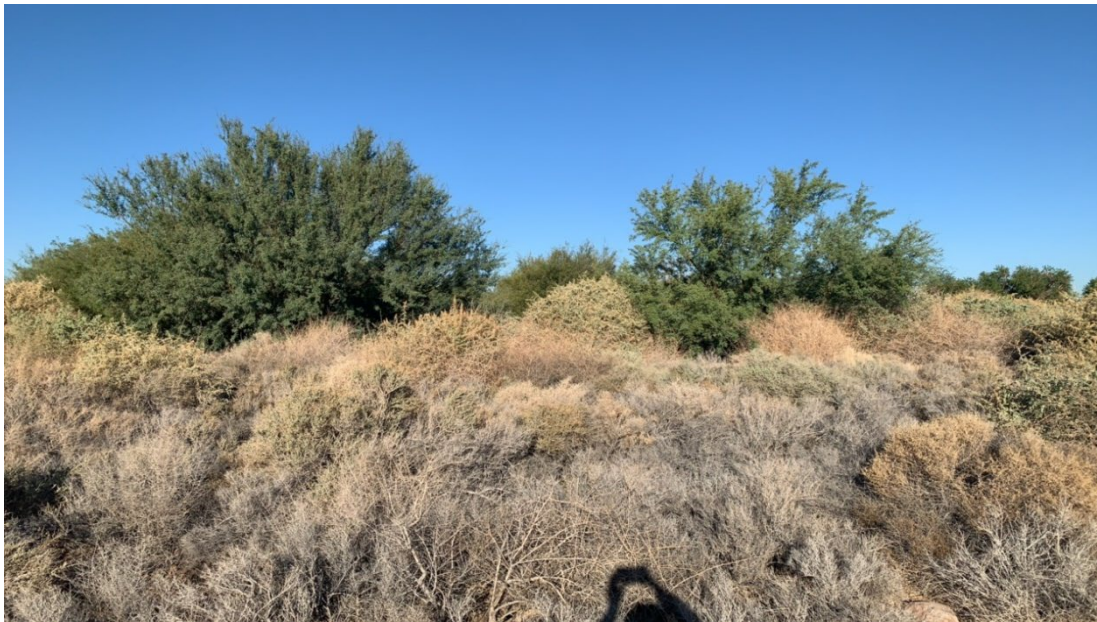
Figure 12. Photo of DU Wetlands No. 2 North showing large amounts of dead vegetation.

Both DU Wetlands No. 2 Emergent (DU2E) and DU Wetlands No. 2 North (DU2N) decreased in noxious species cover. DU2E went from 9.7% to 0.2% and DU2N went from 15% to 2.5%. Since both sites now have low percentages of noxious species, they are currently not good candidates for invasive and other undesirable species removal under the RMP. However, DU2N had extensive dead vegetation and would be a good candidate for enhancement under the RMP (Figure 12).

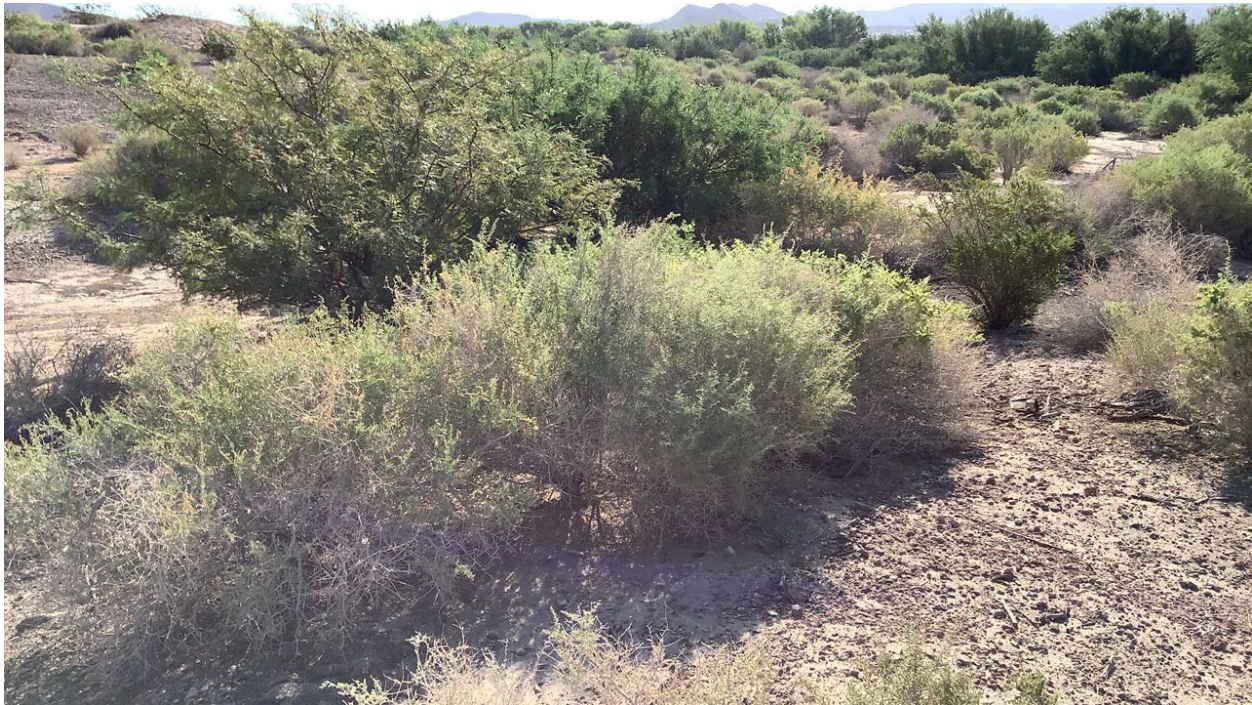
Figure 23. Aerial photograph of the 2023 delineated Site 111 revegetation site.

Site 111 was planted as a single site, but due to being one of the larger revegetation sites along the Wash, it is broken up into 26 monitoring areas (Table 20, Figures 22 and 23). All areas were monitored using ArcGIS in 2023. This site is in its 16th growing season so there is not much change year to year. Total cover went from 81.4% measured using ArcGIS in 2021 to 78.7% in 2023.

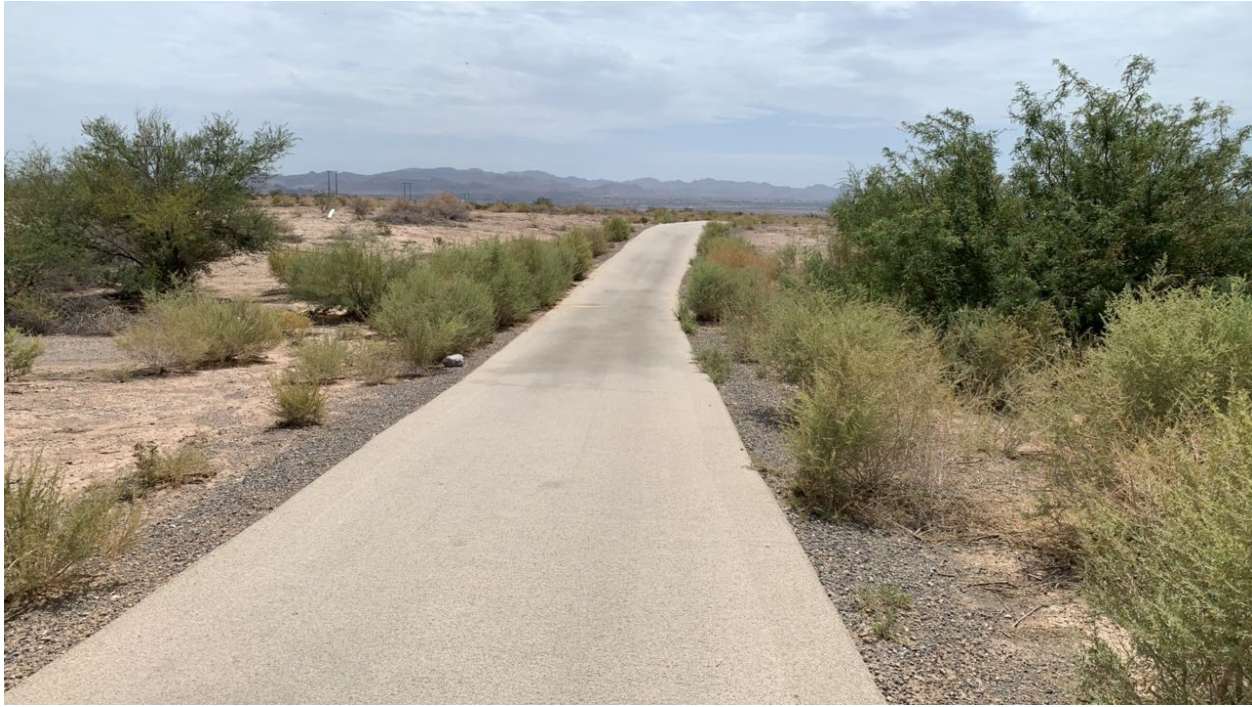
Figure 28. Photo of Downstream Upper Diversion North-2.

Total cover at Downstream Upper Diversion North (DUDN; Figure 28) decreased slightly from 2022, to 38.9%. At less than 50% total cover on its recorded 10.10 acres in 2023, this site is a good candidate for enhancement under the RMP.

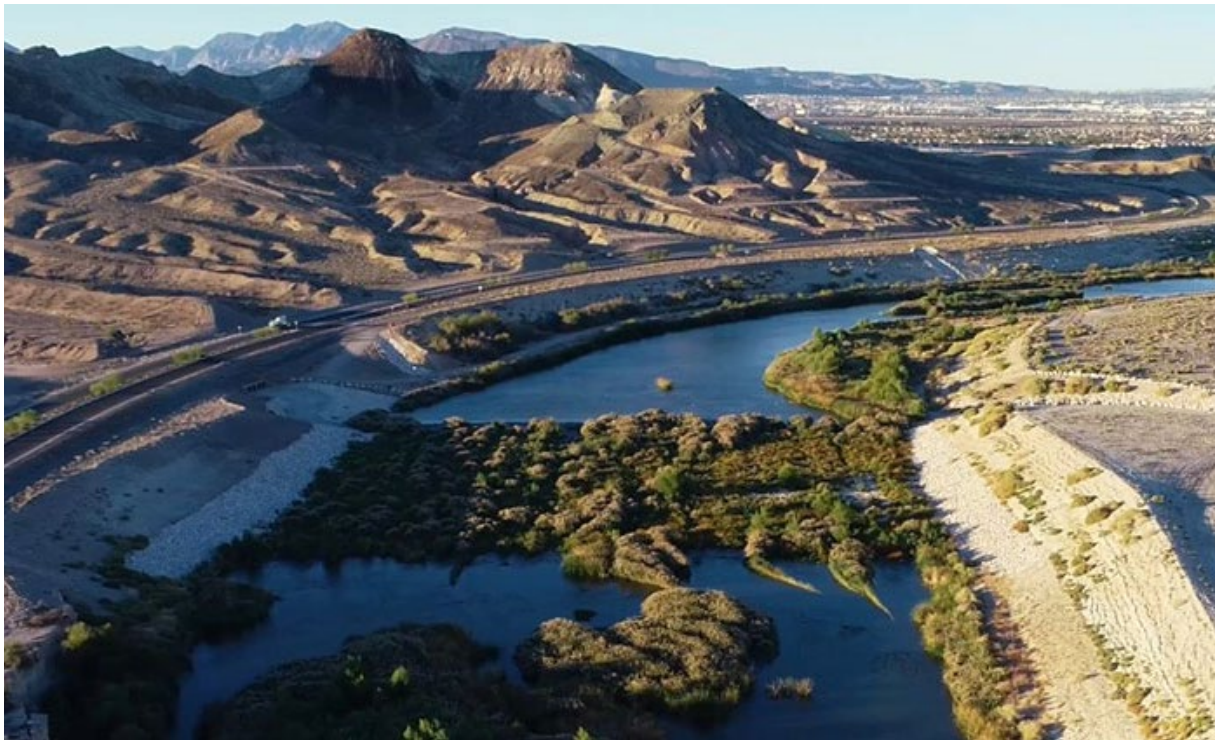
Figure 29. Aerial image of Three Kids Weir which was constructed in 2015. This weir is currently the largest at 4.67 acres. Photo taken in 2020.

in 2018. The two weirs created after 2018—TW and SMW—show acreage beginning in 2020. Three Kids Weir, which was constructed in 2015, is currently the largest at 4.67 acres (Figure 29). No weirs were cleared during 2023, but plans are in place to resume this work in 2024. As SNWA continues with scheduled maintenance of the weirs, this table will be updated to reflect the years when vegetation was removed. Learning the immediate and long-term impacts of this maintenance will help with future planning. Additionally, understanding how quickly vegetation grows back can help determine the appropriate time between scheduled maintenance.
